# Manhole Inspection Summary

Manhole # S31O\_\_001MH

Insp Date: **12/29/08 9:30 AM**

**Location** Address: **600 W Hamburg St**

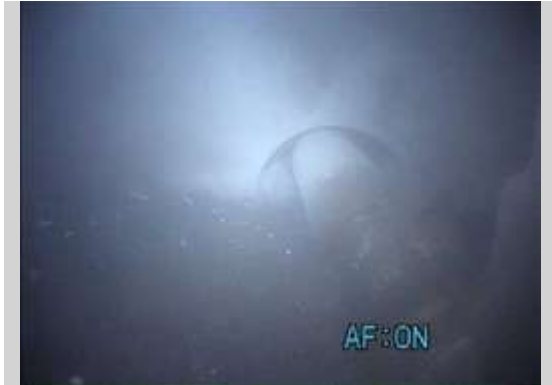
12 O'Clock Outflow

8 in. Circular Gravity Sewer  
Pipe Out @ 12 O'Clock

Infiltration: **None** Pipe Seal Cond: **Unknown**
